Building Damage Depending on Earthquake Vibration Period and New Technology Issues

TSUNEO ICHIGUCHI
Safety and System Unit

SHOZO MATSUMURA
Affiliated Fellow

1 Introduction

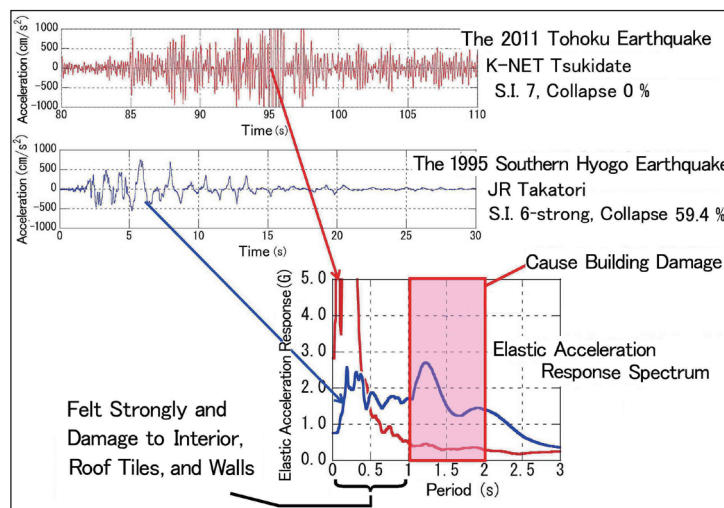
Both the 2011 Off the Pacific Coast of Tohoku Earthquake (that caused the Great East Japan Earthquake Disaster) and the 1995 Southern Hyogo Prefecture Earthquake (that caused the Great Hanshin-Awaji Earthquake Disaster) claimed many lives and caused enormous damage. However, their damage situations are entirely different. The 2011 Off the Pacific Coast of Tohoku Earthquake (hereafter “the 2011 Tohoku Earthquake”) produced catastrophic tsunami damage, but the building damage caused by ground motion was not as serious as that in the 1995 Southern Hyogo Prefecture Earthquake. This was because the ground motion with a period of 1 second or less, which affects buildings little, was predominant in the 2011 Tohoku Earthquake. On the other hand, the ground motion with a period of 1 to 2 seconds, which causes heavy damage to buildings, was predominant in the 1995 Southern Hyogo Prefecture Earthquake (see Figure).

Figure : Comparison of Ground Motions in the 2011 Tohoku Earthquake and the 1995 Southern Hyogo Prefecture Earthquake. (Provided by Y. Sakai)

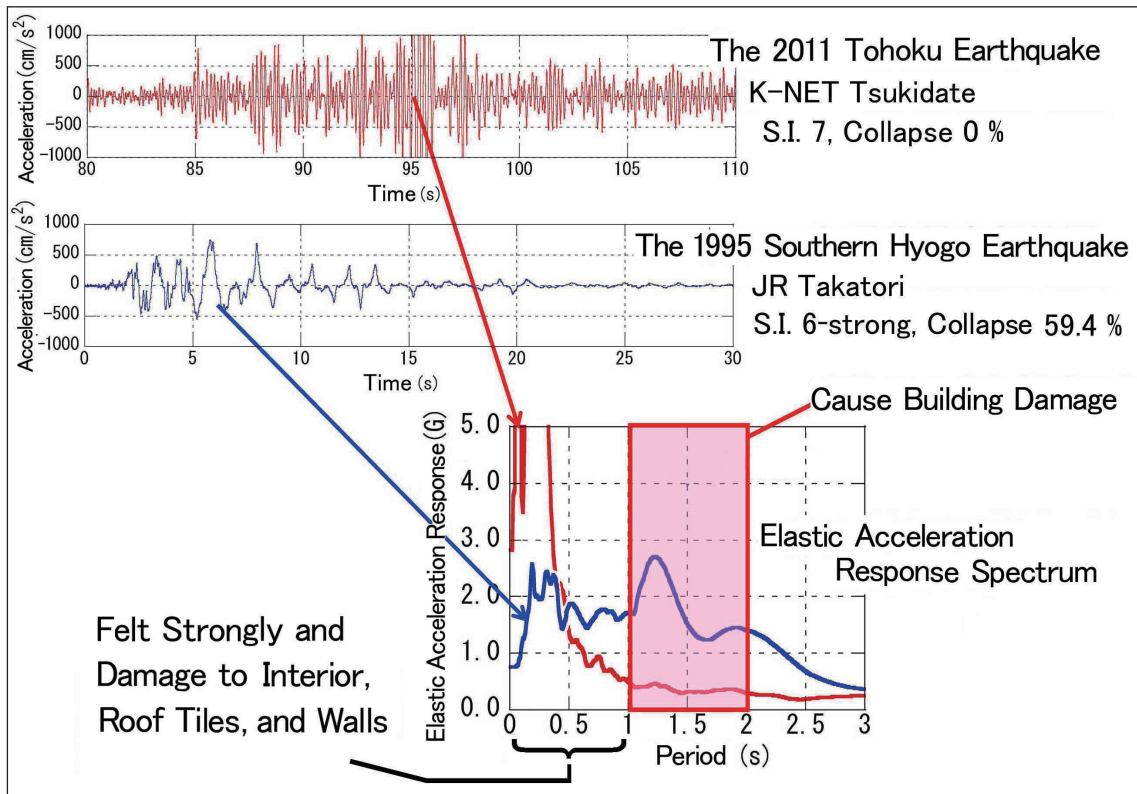
In Fig. 4, we compare the typical ground motion of the 2011 Tohoku Earthquake and that of the 1995 Southern Hyogo Prefecture Earthquake (hereafter, the 1995 Southern Hyogo Earthquake). These ground motions were observed at K-NET Tsukidate in Miyagi prefecture and the Takatori Station (of West Japan Railway Company) in Hyogo prefecture, respectively. While the building collapse rate for Tsukidate was 0% at seismic intensity 7, the rate for Takatori was 59.4% at seismic intensity 6-strong, showing a large difference.

The characteristics of the two ground motions shown in Fig. 4 are quite different from each other. While strong short-period ground motion continued for a long time in the 2011 Tohoku Earthquake, relatively long-period ground motion was observed in the 1995 Southern Hyogo Earthquake. The vertical axes of upper two graphs represent the acceleration of

Figure 4 : Comparison of Ground Motions in the 2011 Tohoku Earthquake and the 1995 Southern Hyogo Prefecture Earthquake. (Provided by Y. Sakai)

ground motions in units of cm/s^2 , which we usually call as “gal.” Another unit “G,” where $1\text{G} = 980 \text{ cm/s}^2$ (gravitational acceleration), is used for acceleration response in the lower figure. In the graph for the 2011 Tohoku Earthquake, the maximum acceleration exceeded 1,000 gal, but we have omitted the part beyond 1,000 gal to simplify the graph.

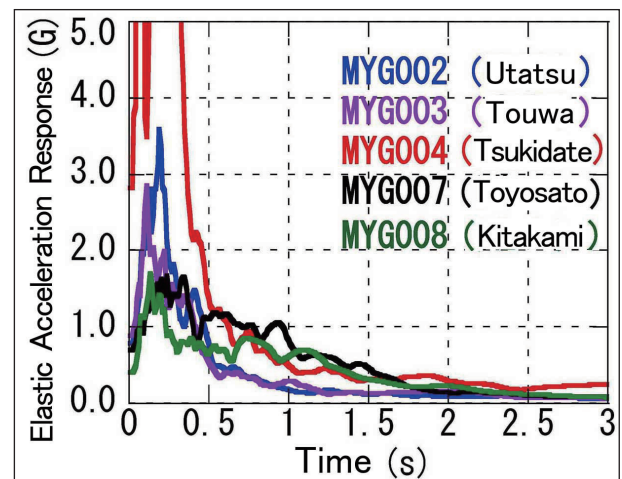
of 1 to 2 seconds (see Fig. 5). This result reveals the reason why the 2011 Tohoku Earthquake did not inflict so much damage to buildings. Namely, it was because the earthquake had little ground motion that affects buildings.

Figure 5 : Spectrum of the Elastic Acceleration Response at Other Observation Stations. (Provided by Y. Sakai)

The difference between the characteristics of the two ground motions becomes apparent when we draw a graph showing the relationship between vibration intensity and vibration period (i.e., the elastic acceleration response spectrum). The elastic acceleration response of the 2011 Tohoku Earthquake was larger at a vibration period of 0 to 0.5 seconds, but that of the 1995 Southern Hyogo Earthquake was larger at a vibration period of 1 to 2 seconds. The ground motion with a period of 1 to 2 seconds will cause building damage, and it is suggested that there is a correlation between the intensity of this period vibration and the percentage of damaged buildings. On the other hand, ground motions with a period of 0 to 1 second are felt more by people and have a correlation with damages of room interior and non-structural materials such as roof tiles and walls.

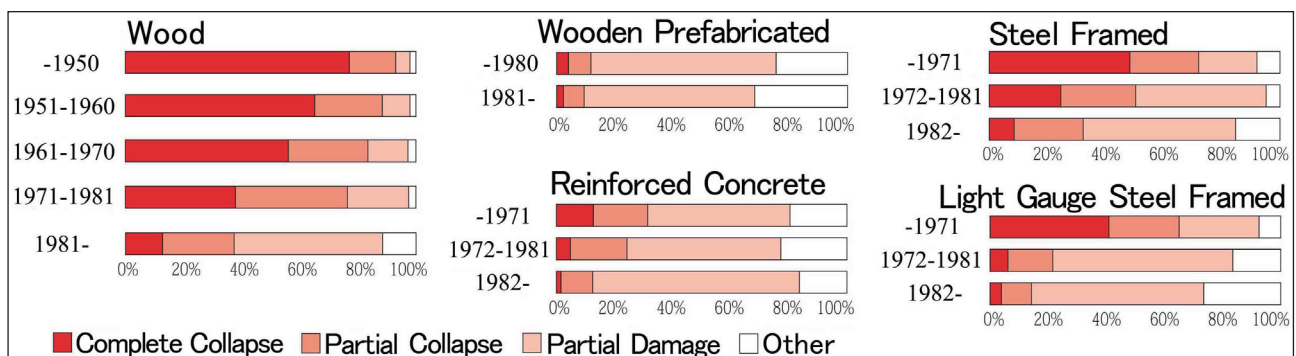
Many houses damaged by the earthquake were built before the June 1981 amendment to the Building Standards Act. Moreover, the older they are, the more houses are seriously damaged (see Fig.7). At some places in the belt zone of a seismic intensity of 7 stretching east to west on the center of the city, more than 90% of buildings and houses were fully or partially collapsed. Many people were also hurt or killed in the belt zone.

Figure 7 : Damage Situation of Buildings in Ashiya City (Reprint from Ref. 6)

Ashiya city, a city with a population of about 90,000 people, published a detailed report titled “Ashiya City: Damage to Buildings and Restoration of Them^[5],” which included results of all building survey in the city. Among all 15,421 buildings in the city 4,722 were fully destroyed and 4,062 were partially destroyed, accounting for 57% of all buildings in the city. There were 10,514 wooden houses, which were the most in number, and about 70% of them were fully or partially

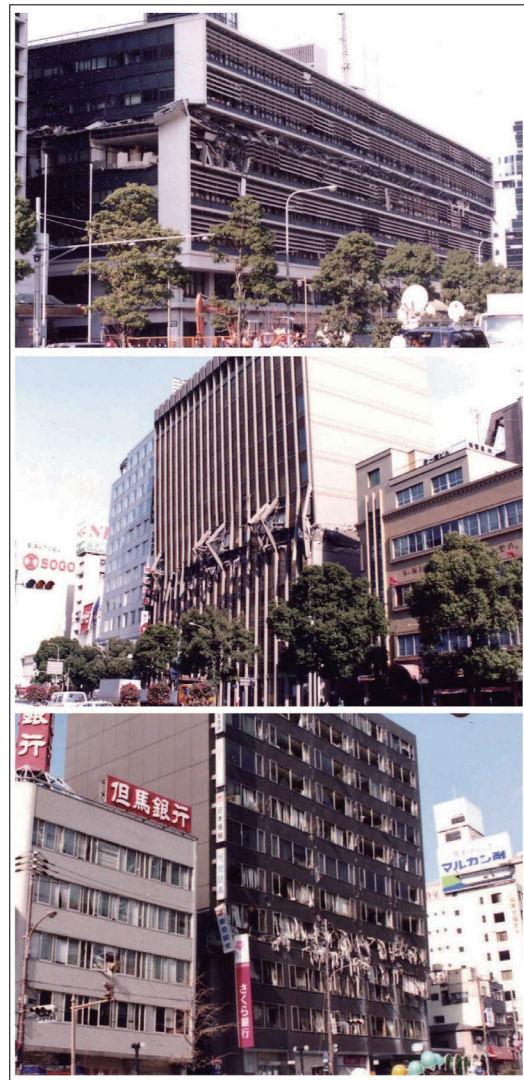
Figure 8 : Story collapse of Large Buildings. (Provided by Y. Sakai)

The phenomenon of the upper floor dropping due to the snap of posts is called “story collapse.” The story collapse occurred not only in wooden houses, but in steel-framed and RC buildings (see Fig. 8). Fortunately, the story collapse in large buildings did not kill many people because the 1995 Southern Hyogo Earthquake struck in the early morning, at 5:46 a.m. We can easily imagine that the story collapse would have killed many people in large buildings such as department stores if the earthquake occurred during the daytime.

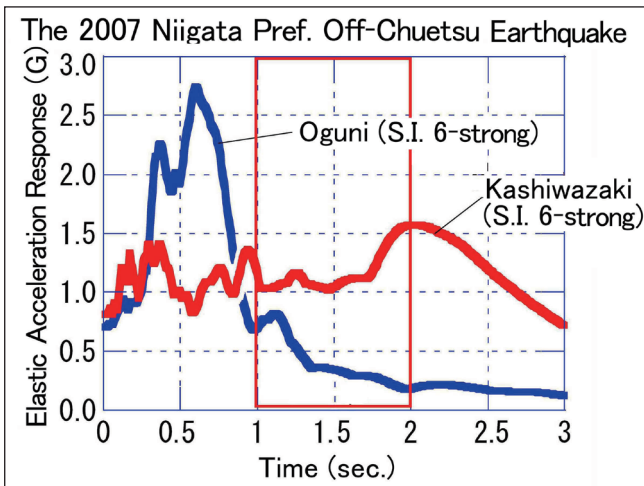
Figure 10 : Spectrum of Elastic Acceleration Response in the 2007 Niigata Pref. Off-Chuetsu Earthquake. (Provided by Y. Sakai)

of one to two seconds) at many locations is denoted by an asterisk, and at limited locations by a circle. It is unknown whether the 2003 earthquake with hypocenter in Northern Miyagi Prefecture caused slightly short period ground motions because some of the seismograph traces were lost. In Table II, we may find that there is a strong correlation between a star or circle and the number of buildings damaged. The 2011 Tohoku Earthquake seriously damaged a large number of buildings, but most of them were damaged by the tsunami rather than by ground motion. On the morning following the 2011 Tohoku Earthquake, however, the earthquake with hypocenter near the Border between Nagano and Niigata seriously damaged many houses in Sakae village (Nagano prefecture) and Tokamachi city (Niigata prefecture).

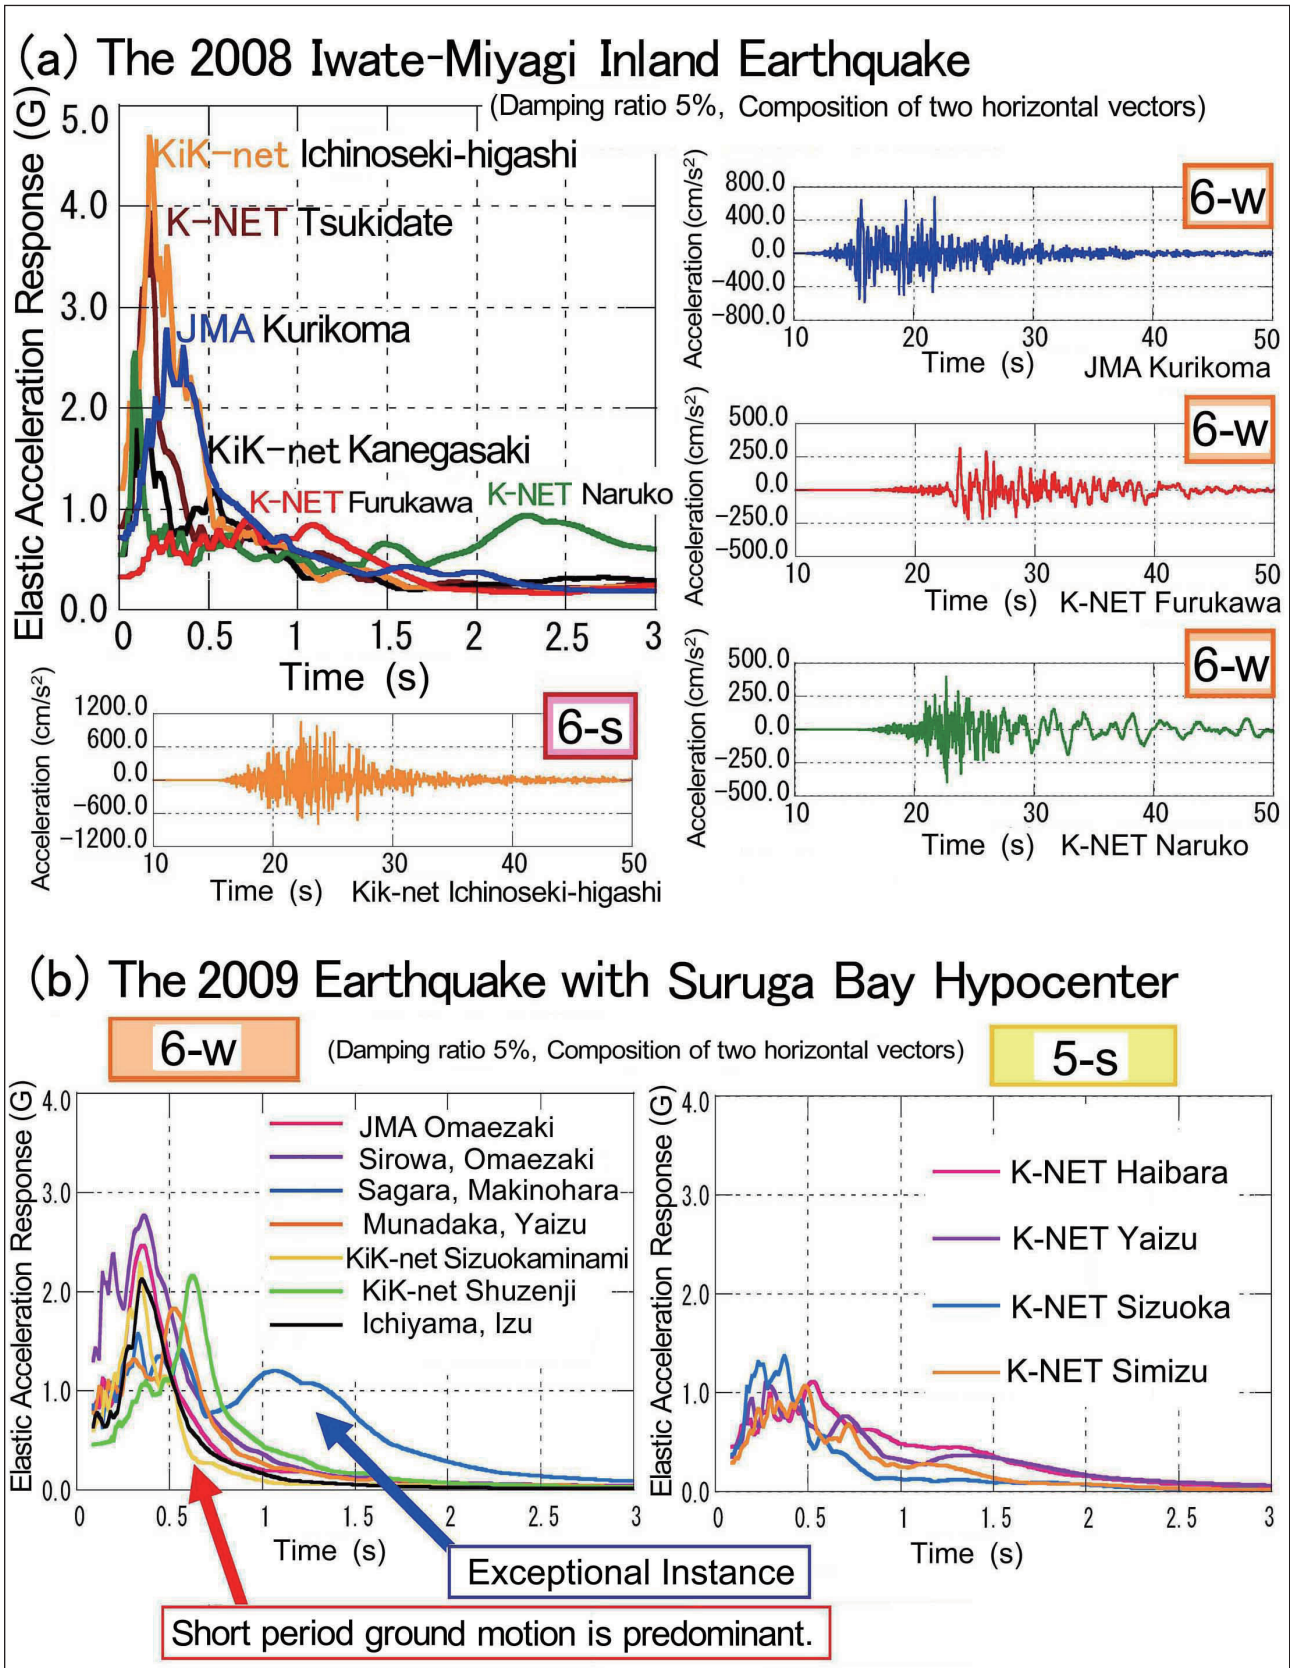
Figure 11 : The Elastic Acceleration Response Spectra in Two Major Earthquakes. (Provided by Y. Sakai)

Outside the survey areas, however, there were a total of 176 buildings collapsed and 23 people dead or missing at the time of the 2008 Iwate-Miyagi Inland Earthquake. Furthermore, the Ichinoseki-nishi observation station in Iwate prefecture recorded the seismic acceleration 4,022 gal that was the largest in recorded history. Earthquakes with a maximum seismic intensity larger than 6-weak, which have been believed to cause complete or partial collapses of buildings, occur 1.3 times a year in average. In terms of damage rate, however, the damage is clearly smaller than assumed in most earthquakes. Rather, the 1995 South Hyogo Earthquake that caused serious building damage corresponding to the seismic intensity is regarded as an exceptional case. This indicates that building damage caused by earthquakes cannot be explained by the single indicator of seismic intensity.

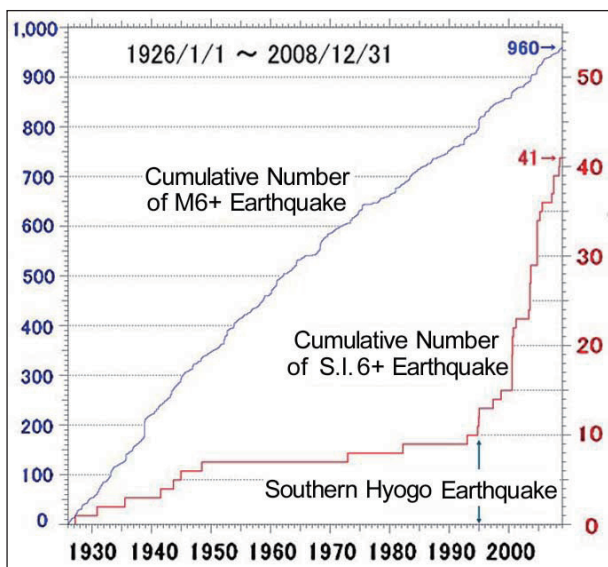
Figure 12 : Cumulative Number of Large Earthquakes. (Reprint from Ref. 10)

The increase in large-intensity earthquakes has been explained as a result of the increasing number of observation stations. It is because the network with many stations would not miss the area experiencing maximum seismic intensity. The explanation seems to be reasonable at first, but it is not obvious that it can explain a rate of occurrence that is 15 times higher. There is a possibility that a part of discrepancy in occurrence rate is caused by a difference between the current instrumental seismic scale and the former scale.

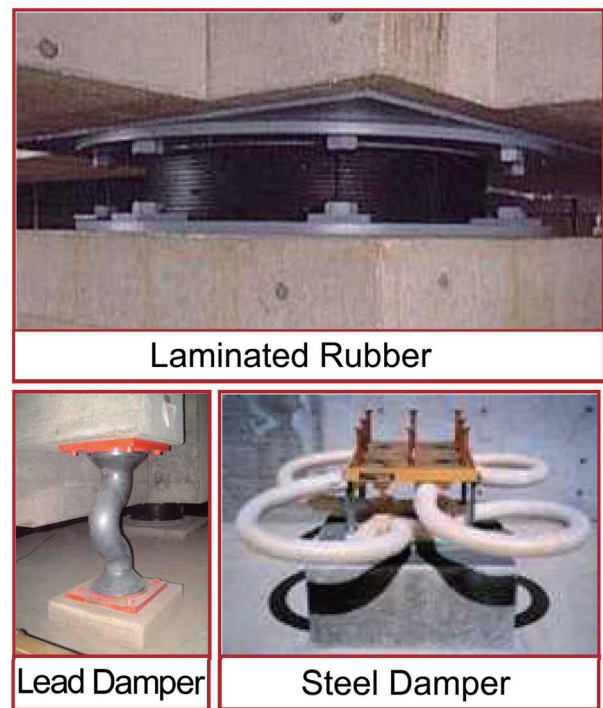
Differently from vibration damping, a seismic isolation structure prevents ground motions from transmitting to the building by installing laminated rubber or steel dampers on the foundation of building as shown in Fig. 15. The seismic isolation structure makes it harder for ground motions to enter the building by prolonging a natural period of the whole building including seismic isolation equipment (see Fig. 13). When the natural period becomes long, the force acting on interior portions of the building becomes smaller while the deformation of the building becomes larger.

The structure concentrates such deformation on the laminated rubber or steel dampers so as to prevent damage to the upper part of the building. However, we need to pay sufficient attention to wind pressure when installing a seismic isolation system in a super-

Figure 15 : Structural Members of Seismic Isolation. (Provided by S. Sakai)

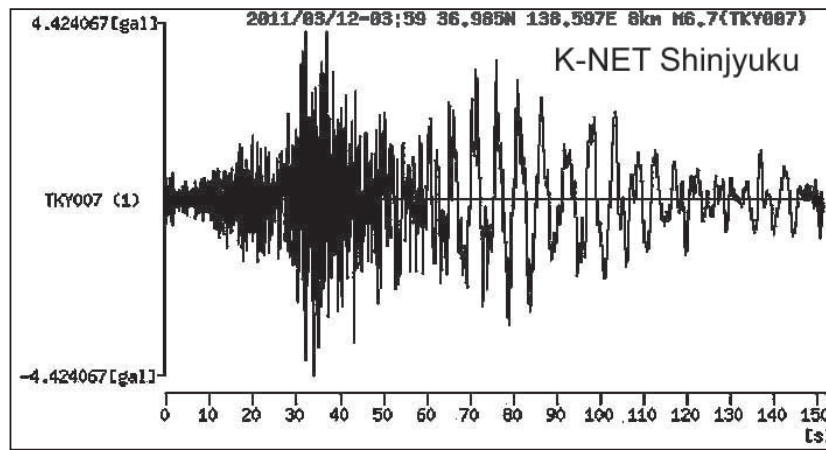
The 2011 Tohoku Earthquake was the first case in which super-high rise buildings in the Tokyo metropolitan area swayed heavily for over 10 minutes. For instance, super-high rise buildings in Shinjuku experienced the swing up to 108 cm for 13 minutes. The scene has been video recorded and can be viewed on video websites. In the Tokyo metropolitan area, aftershocks accompanying “long period ground motion” were also observed. Figure 17 shows the ground motion observed in Shinjyuku at 3:59 a.m. on March 12. Though the acceleration of this aftershock is not large, the ground motion with a period of 5.6 seconds is clearly observed from 65 to 110 seconds in Fig. 17.

Figure 17 : Aftershock Ground Motion Observed at Shinjuku (from Ref.2)
